TOWNSHIP LINE DAM

NDI - PA 00625
PA DER 15-266

PHASE I INSPECTION REPORT
NATIONAL DAM INSPECTION PROGRAM

Name of Dam:	Township Line Dam
State Located:	Pennsylvania
County Located:	Chester
Stream:	East Branch Chester Creek
Coordinates:	Latitude 39° 59.1', Longitude 75° 34.3'
Date of Inspection:	June 12, 1979

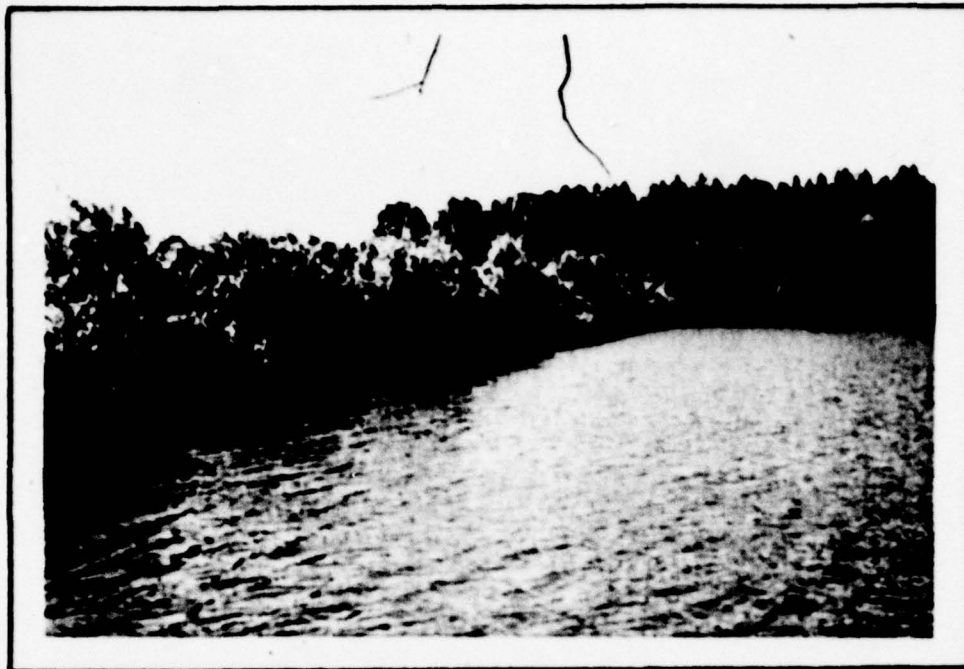
b. Dam. The entire earth embankment is overgrown with heavy brush and tall grass. A few trees up to 25 feet tall are growing on the downstream embankment slope adjacent to the spillway. The hand-placed riprap on the upstream slope exhibits evidence of displacement perpendicular to the prevailing grade line. The riprap is missing on the upstream slope from the dam crest to the water line in the vicinity of the intake tower access bridge. It is apparent, at many locations, that the riprap had been reset since the dam was put in service. There is no evidence of uncontrolled seepage or slope misalignments, however, observations were severely limited due to dense vegetation. Visual inspection of the structure was limited to walking in a foot path along the top of dam and inspecting the upstream and downstream slopes at randomly selected locations. An aerial photo was made for the overall view.

a. Visual Observations. The entire embankment is heavily overgrown with brush and tall grass. A few trees with trunk diameters up to 12-inches are growing on the downstream slope adjacent to the spillway. The tree roots may increase the seepage potential through the embankment and uprooting of the trees by high winds could cause substantial volumes of embankment material to be displaced. There were no indications of downstream seepage, slope misalignments or other unstable conditions noted during the visual inspection. It should be noted that the detection of potentially unstable conditions at this site was severely restricted due to the thick vegetation; therefore, until the overgrowth is removed an opinion on the stability of the dam can not be made.

*VIEW SHOWING THE IMPOUNDMENT, GATEHOUSE,
CATWALK AND THE HEAVILY OVERGROWN
EMBANKMENT OF THE DAM*

1. The capacity of the spillway should be increased in accordance with the results of further hydrologic and hydraulic studies.
2. The thick vegetation and trees should be removed from the embankment crest and slopes under the guidance of an engineer. If any signs of distress such as seepage, sloughing or cracking are revealed, the stability of the embankment should be reevaluated by a licensed professional engineer experienced in the design and construction of dams.
3. The exact location of the 8-inch diameter vitrified clay outlet pipe connected to the toe drain system should be determined. The pipe

1. A program should be initiated for removal of excess vegetation from the embankment on a regular basis.
2. A downstream warning system should be developed. During periods of heavy rainfall, the dam should be monitored and downstream residents should be alerted in the event of an impending failure.

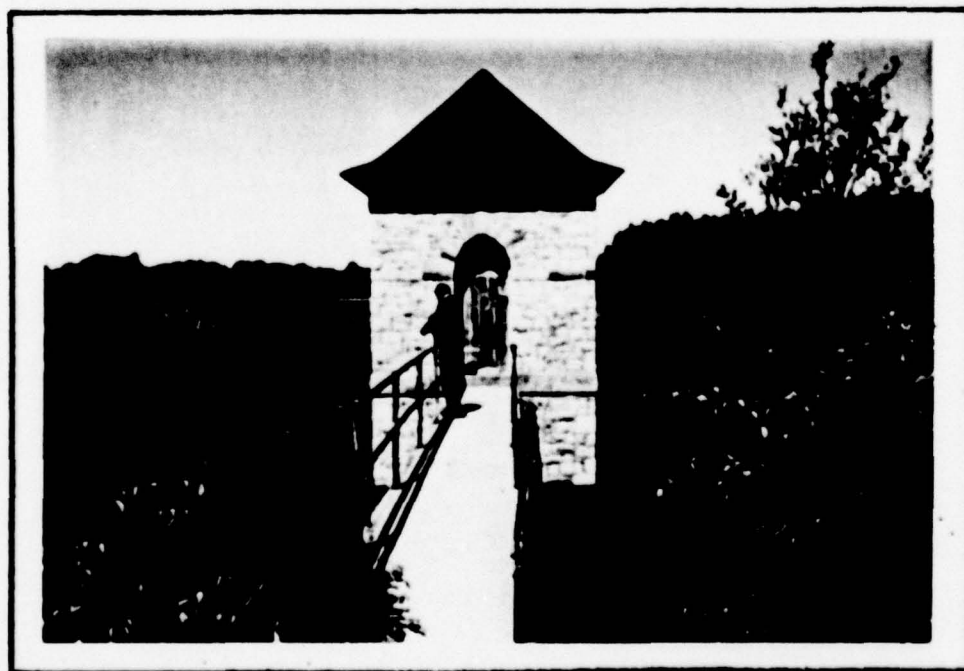
c. Appurtenant Structures. The concrete access bridge to the intake tower is in good condition, however, the steel pipe railing is severely rusted and some sections are missing. The concrete and masonry intake tower, above the water line, is in good condition with no indications of vertical or horizontal misalignments. The gate hoist mechanism could not be observed because the door to the intake tower was locked and the Owner's representative, Mr. David Hughes, did not have the key. According to Mr. Hughes, the gate is operated periodically.

*CATWALK AND GATEHOUSE WITH BROKEN
RAILING ON THE RIGHT SIDE OF THE CATWALK*

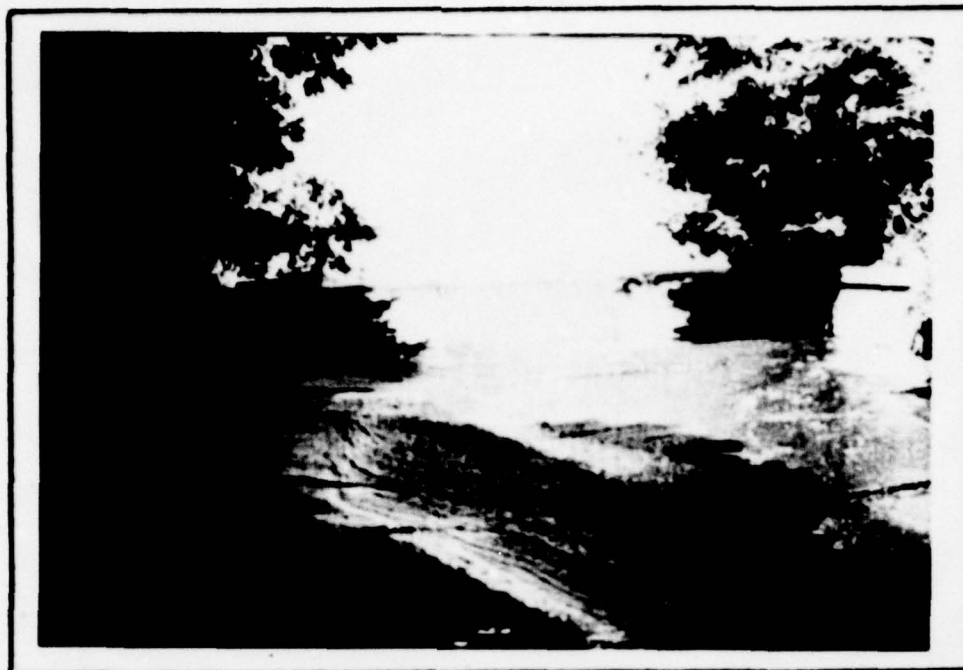
*LOOKING UPSTREAM IN THE SPILLWAY
OUTLET CHANNEL AT THE SPILLWAY*

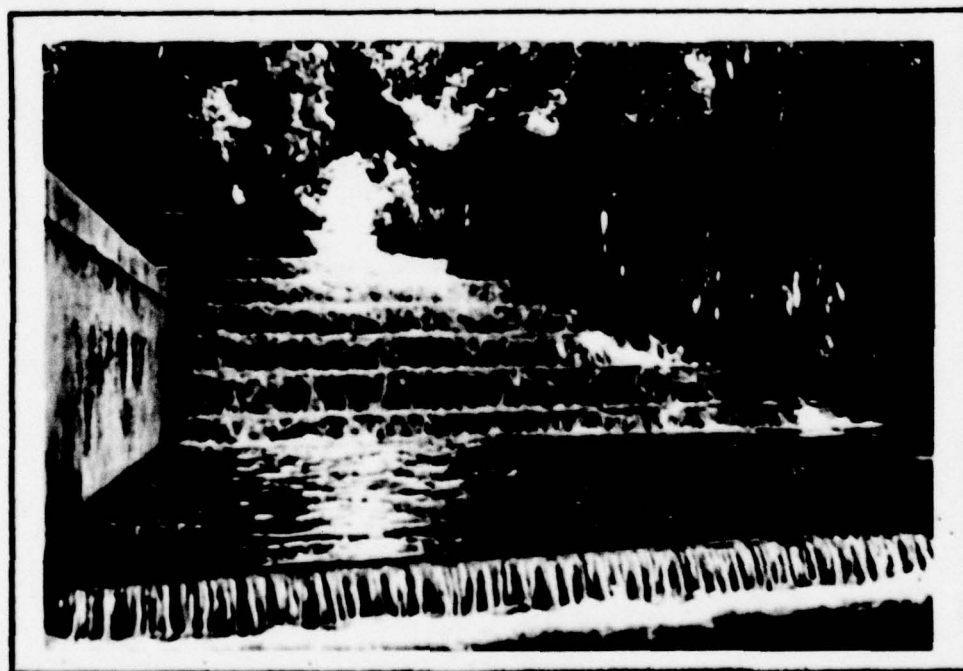
*STEPPED PORTION OF THE SPILLWAY
OUTLET CHANNEL ABOUT 200 FEET
DOWNSTREAM OF THE SPILLWAY*

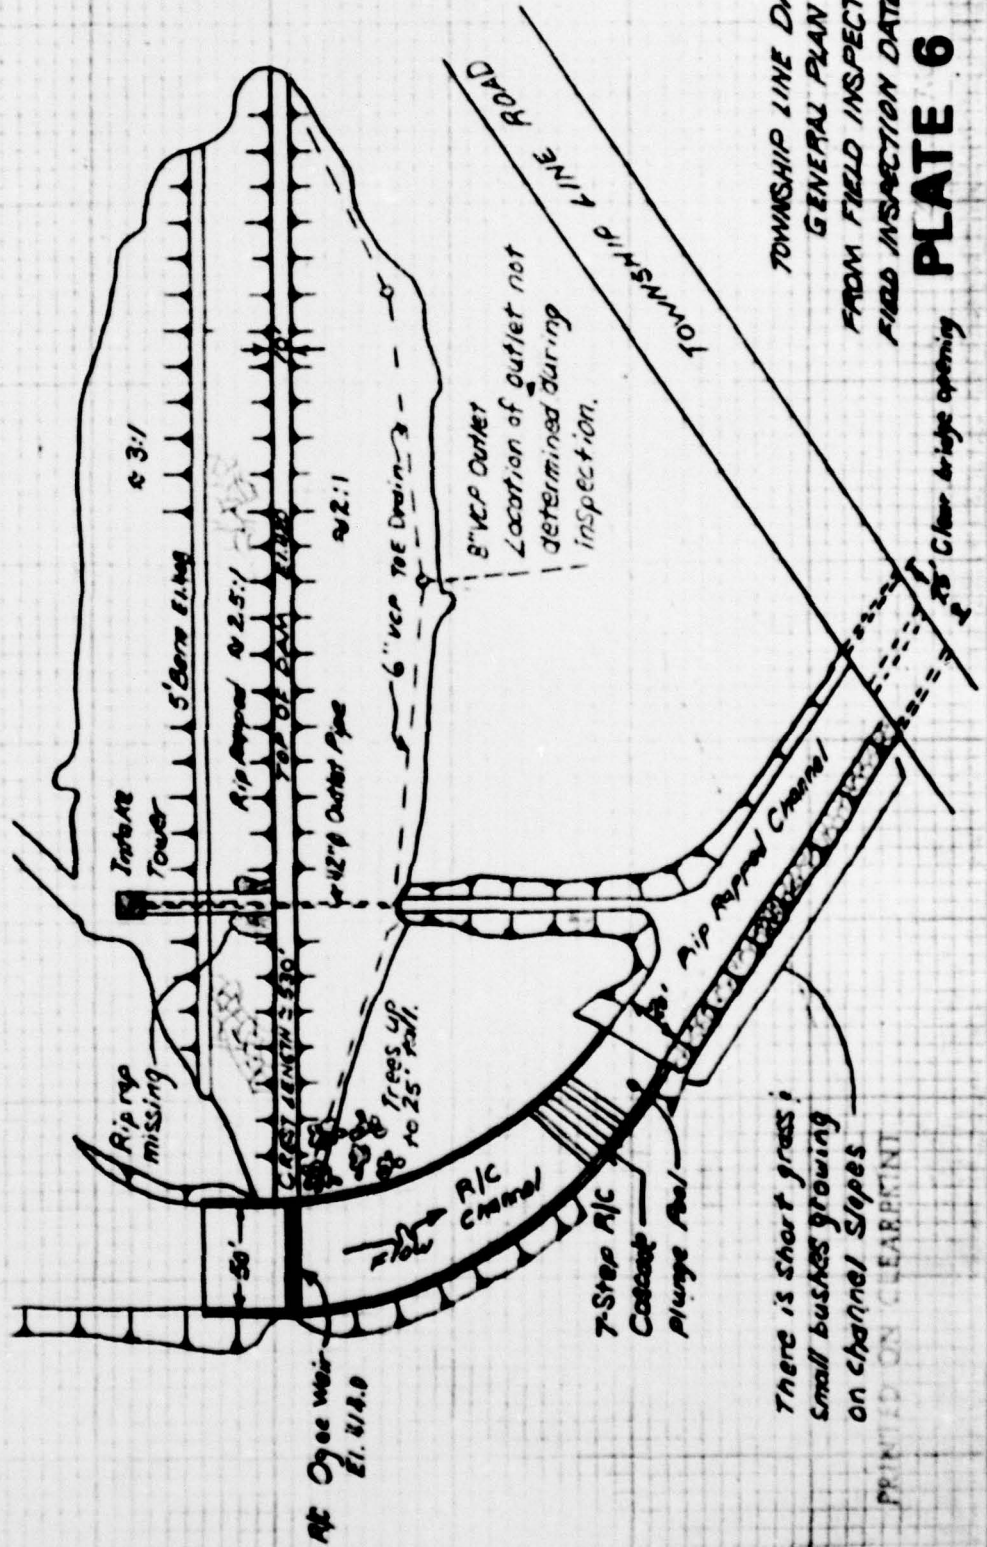
* The entire embankment is overgrown *
with brush, tall grass and small trees.

There is short grass &
small bushes growing
on channel slopes
